Nitro ZV Boat Trailer Winch Mount Analysis

KTO Solutions

20220416

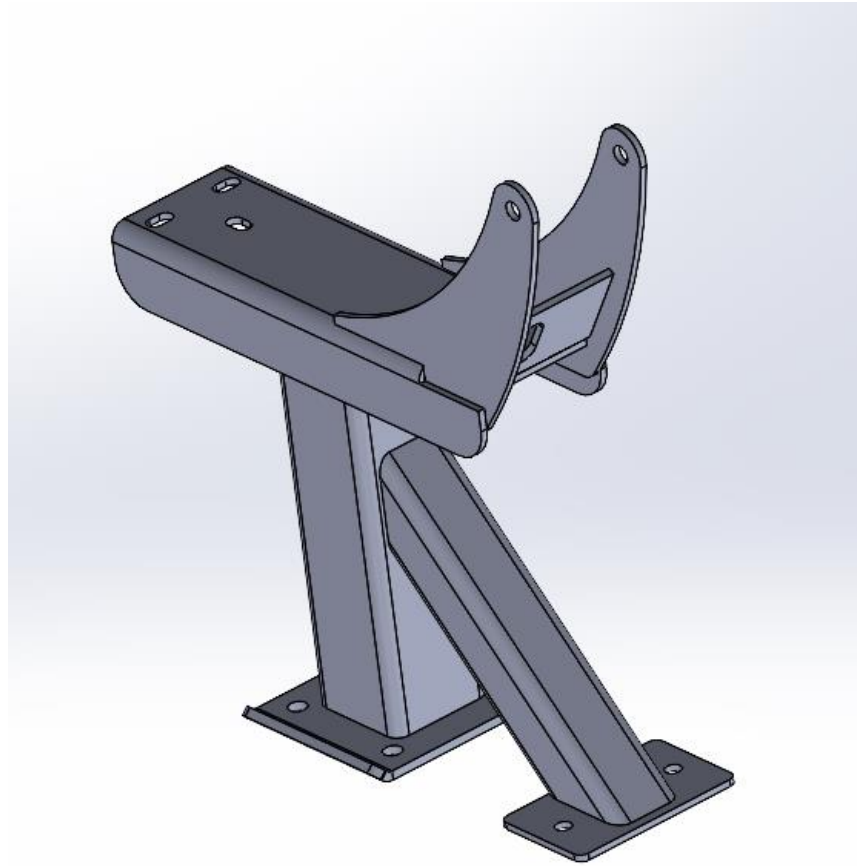
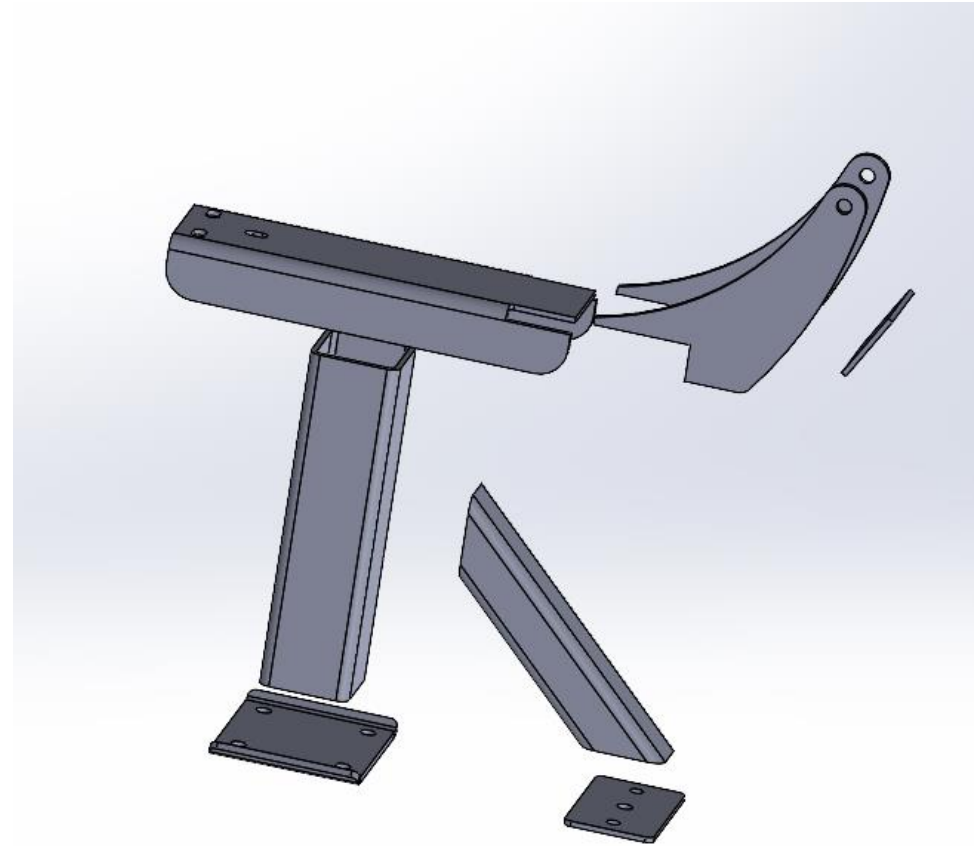
Winch Mount CAD model

- The Drotto Attach bolt “receives” the light latching load in an upward vector. This upward vector overstresses the weld that attaches the winch mount c-channel to the 3x3 tube. You can probably inspect your winch mount today and see rust on each end of that weld. The rust signifies that the weld is already starting to break.
- A secondary issue is the 3/16” mild steel used all the winch mount components except for the mounting feet. When applying “fixes” to the c-channel, the parent material is easily overstressed. This condition requires careful application of measures to guide the load through the winch mount to minimize promoting downstream failures.

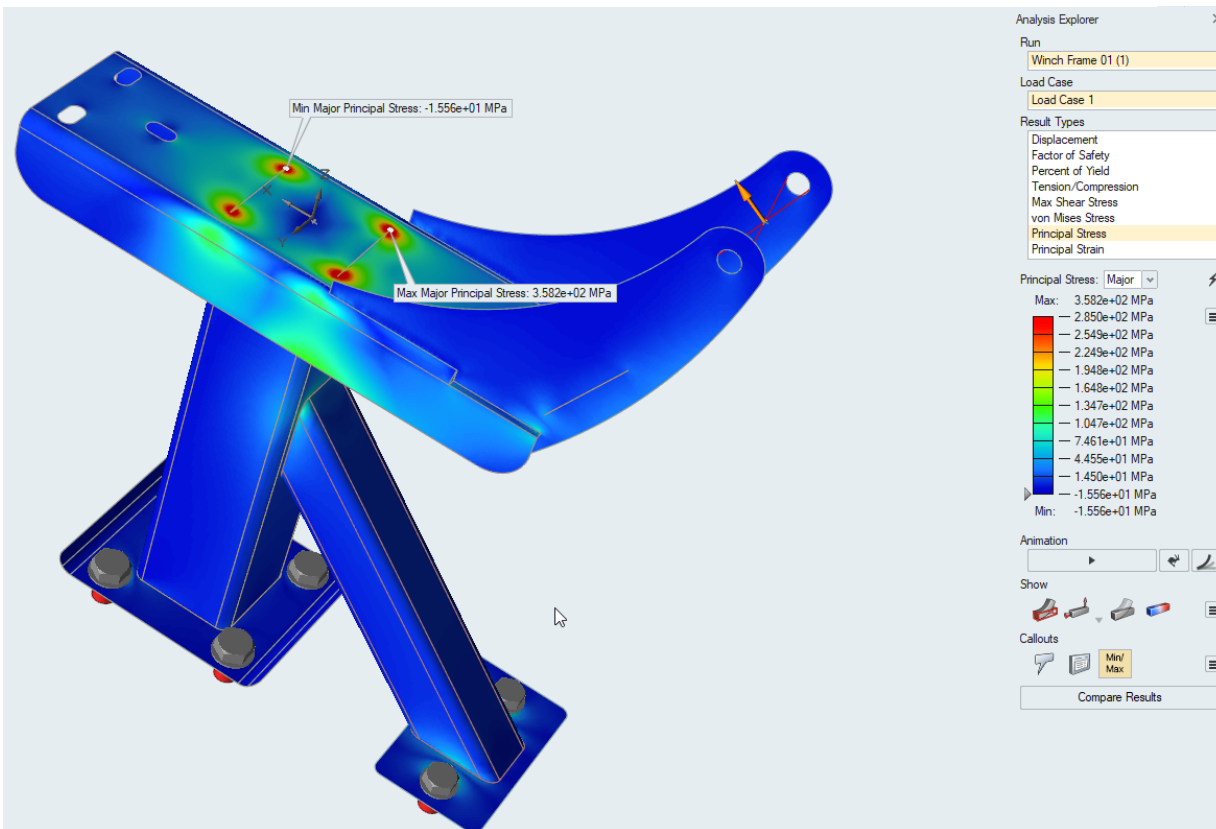
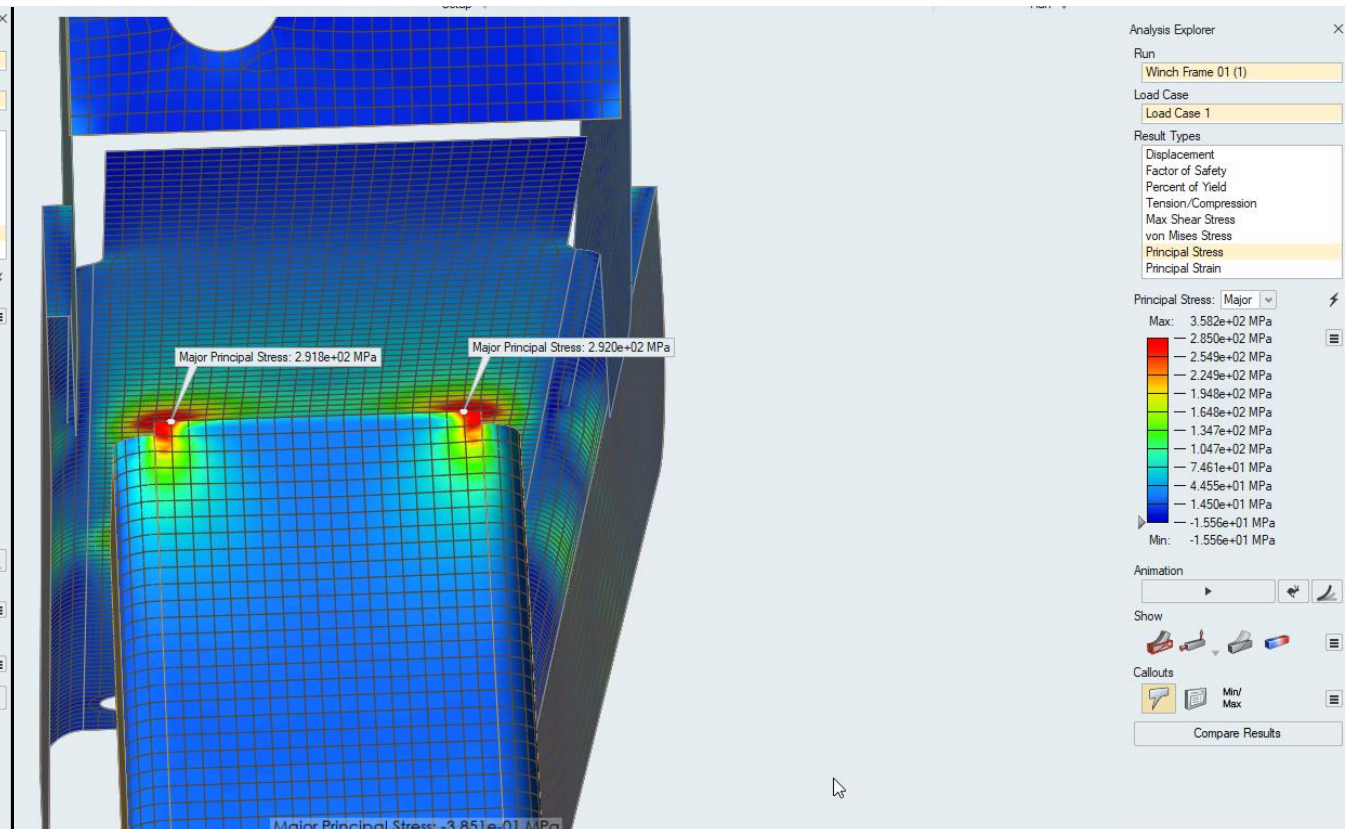
Initial FEA Result – all 4 weld corners light up

- The root cause of the failures is due to the minimal weld installed to attach the winch mount c-channel to the 3x3 upright tube. Any excess push by the boat puts the weld in tension and it fails on each end of the weld that is nearest the boat.

the applied load is 500lbf up 30° from horizontal (it's a 2 ton boat being pushed with a nudge from 300-400hp)

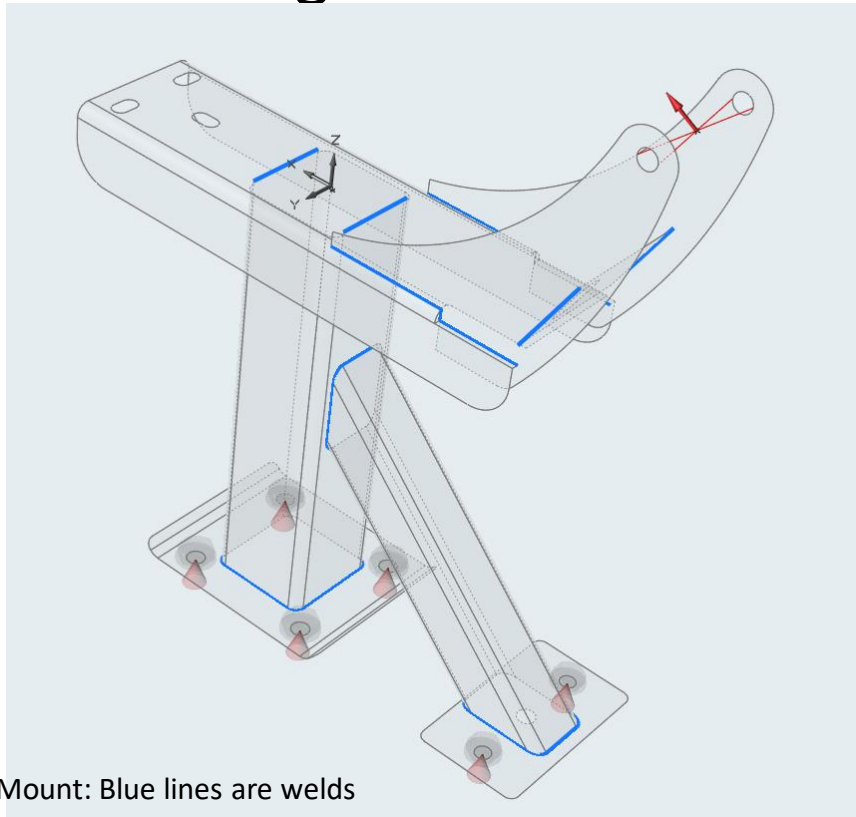
Original Mount: Blue lines are welds

- The first obvious fix is to complete the welding of the 3x3 tube to the winch base. This is done by using a cutoff wheel from the top and finishing with a Dremel. Then plug welds are installed.

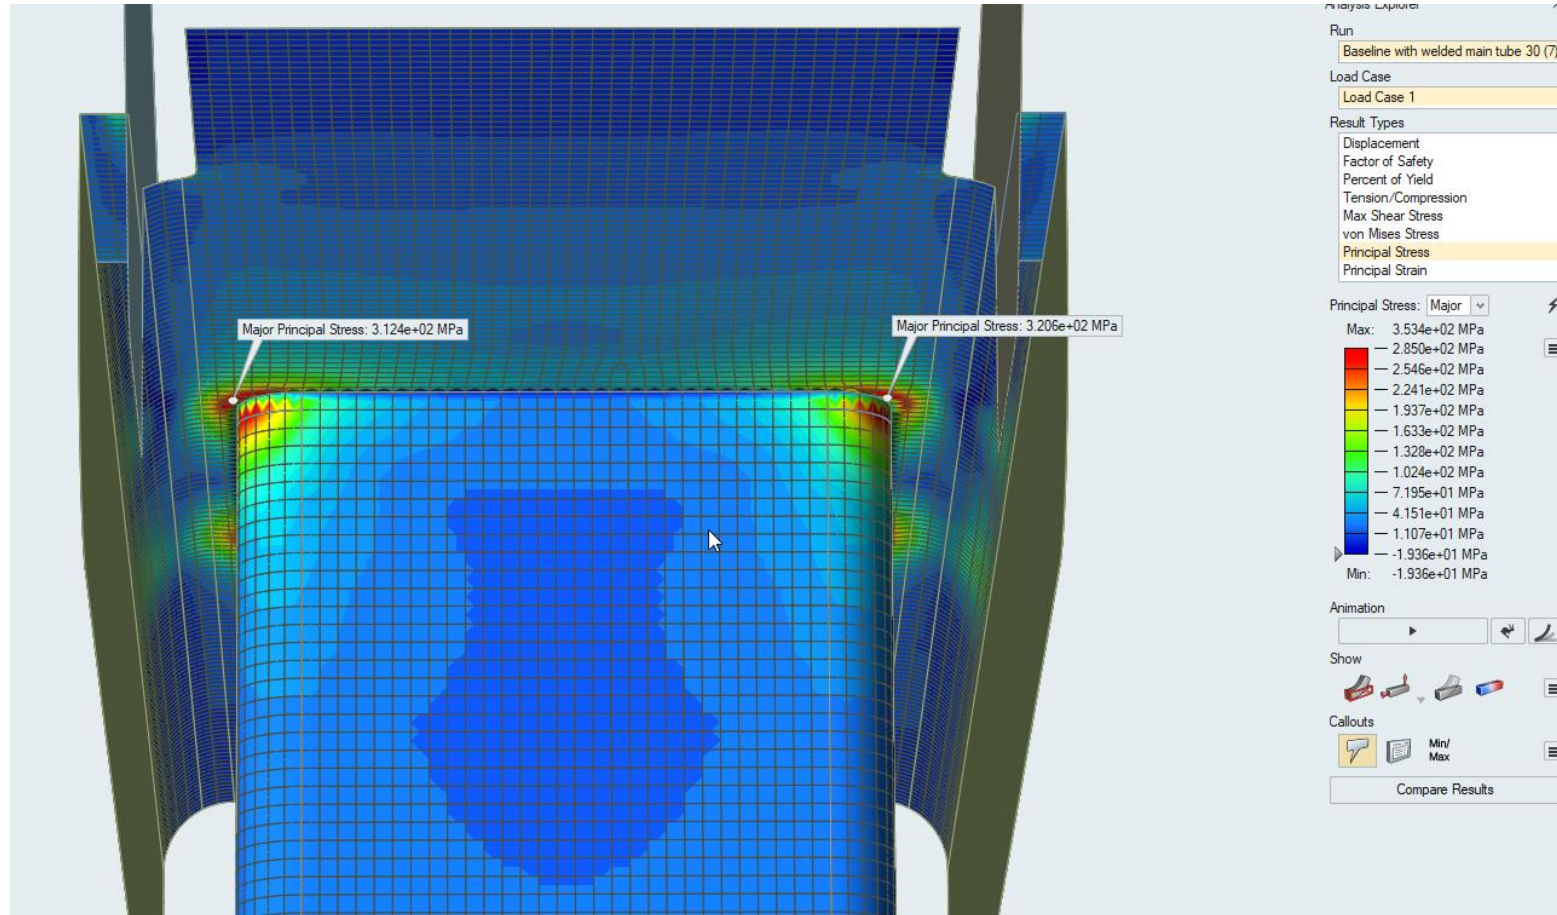
Mod #1 Results: Stress transfers to the thin Winch Base material, a better fix is needed.

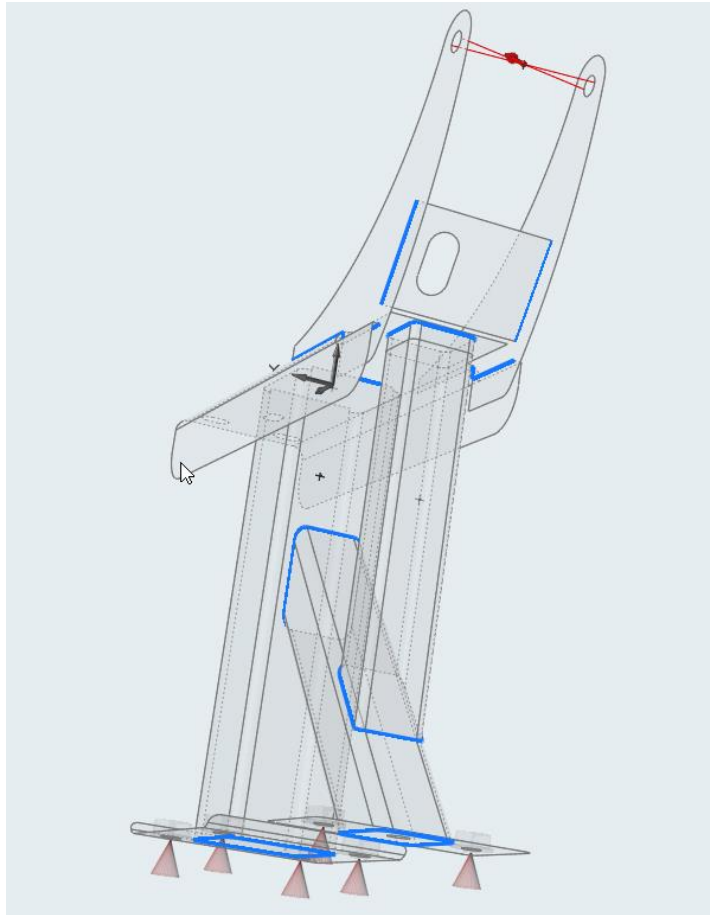
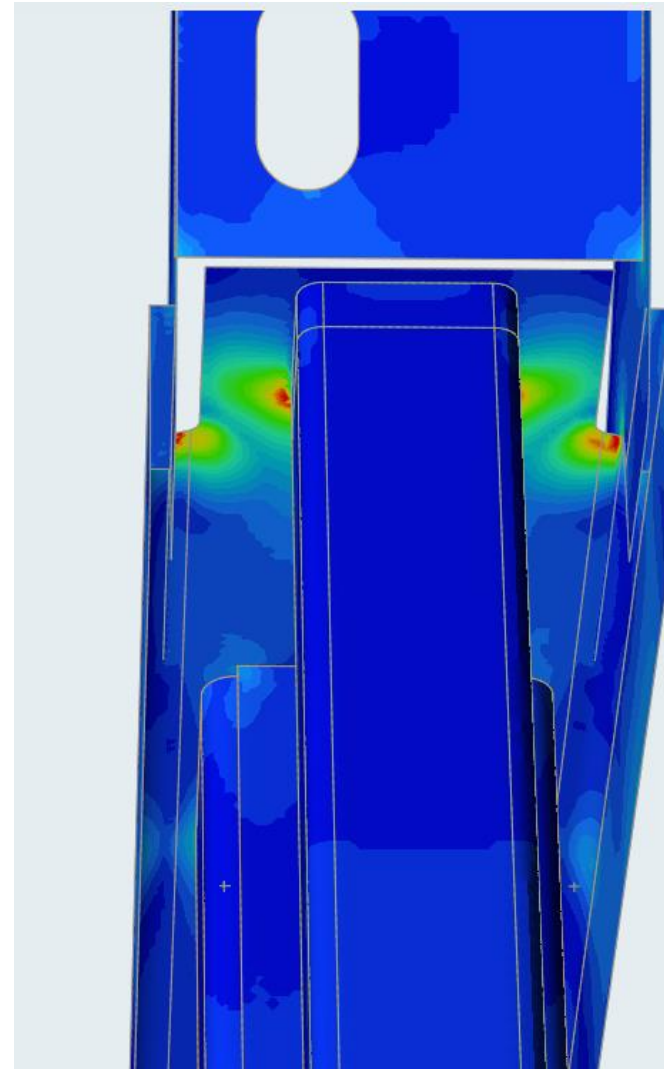
Stress transfers into the winch base material and now the slots light up. The slots can be fixed but overstressing the winch base thickness is not acceptable.

Mod #2: Add a vertical brace tube, remove extra 3x3 tube welds (one change at a time)

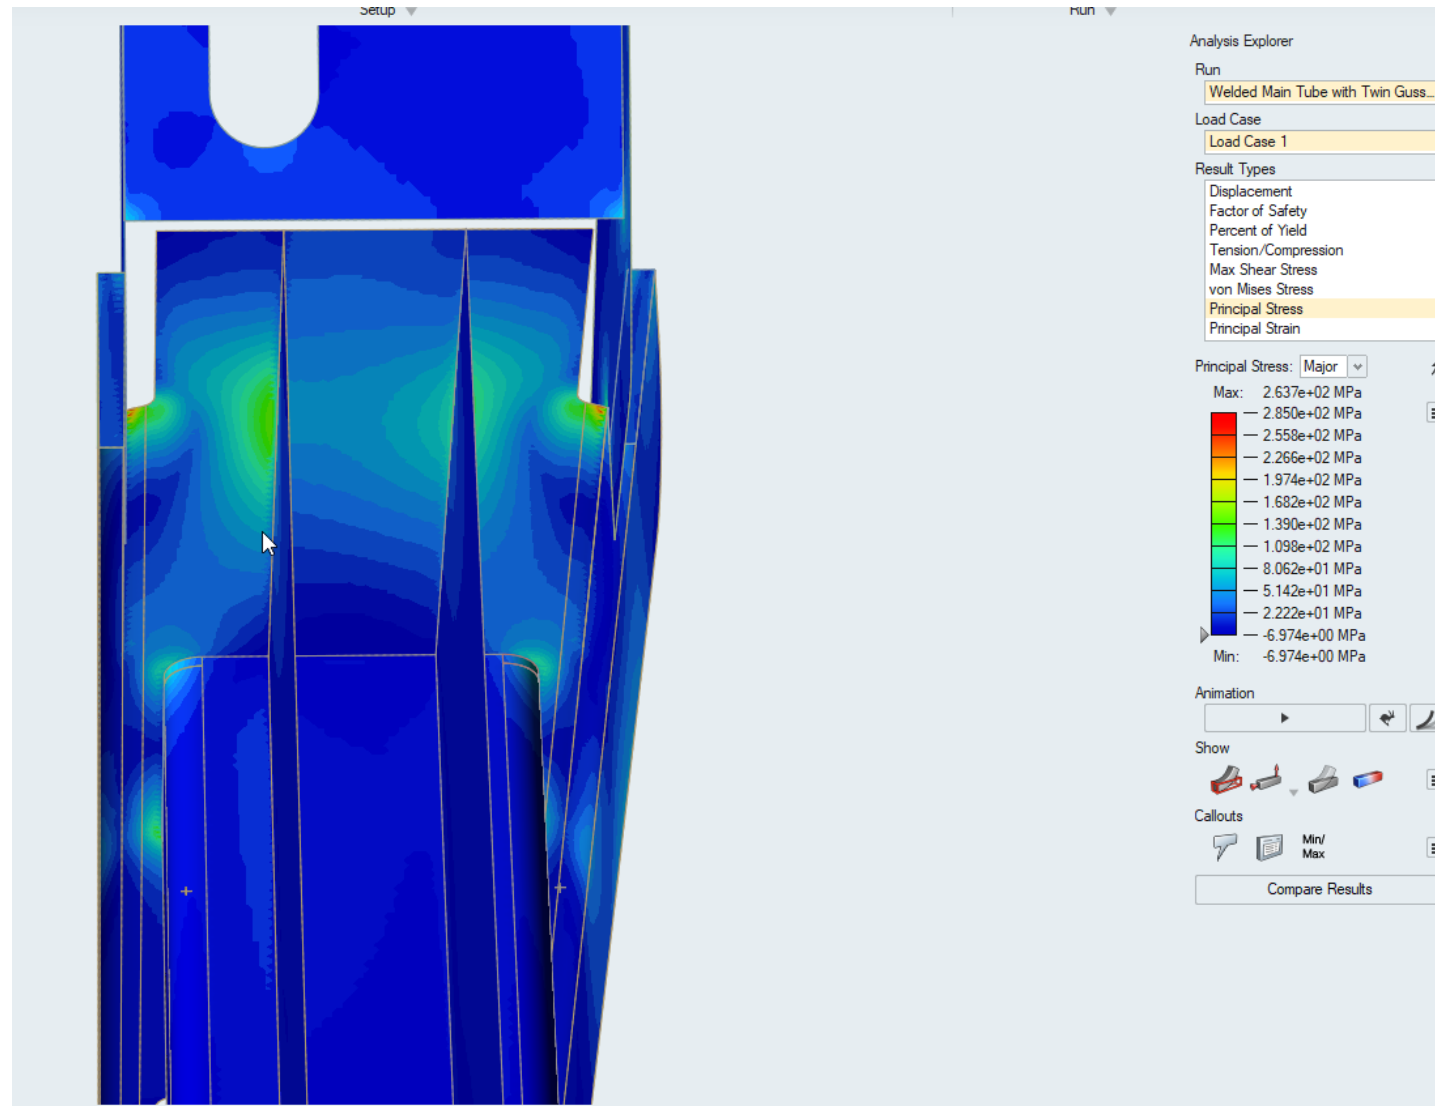
Mod #4 Results: Stress is lowered and slots don't light up as much

Now it looks like we can manage the stress but a MIG tip is not going to fit to full weld the gussets.

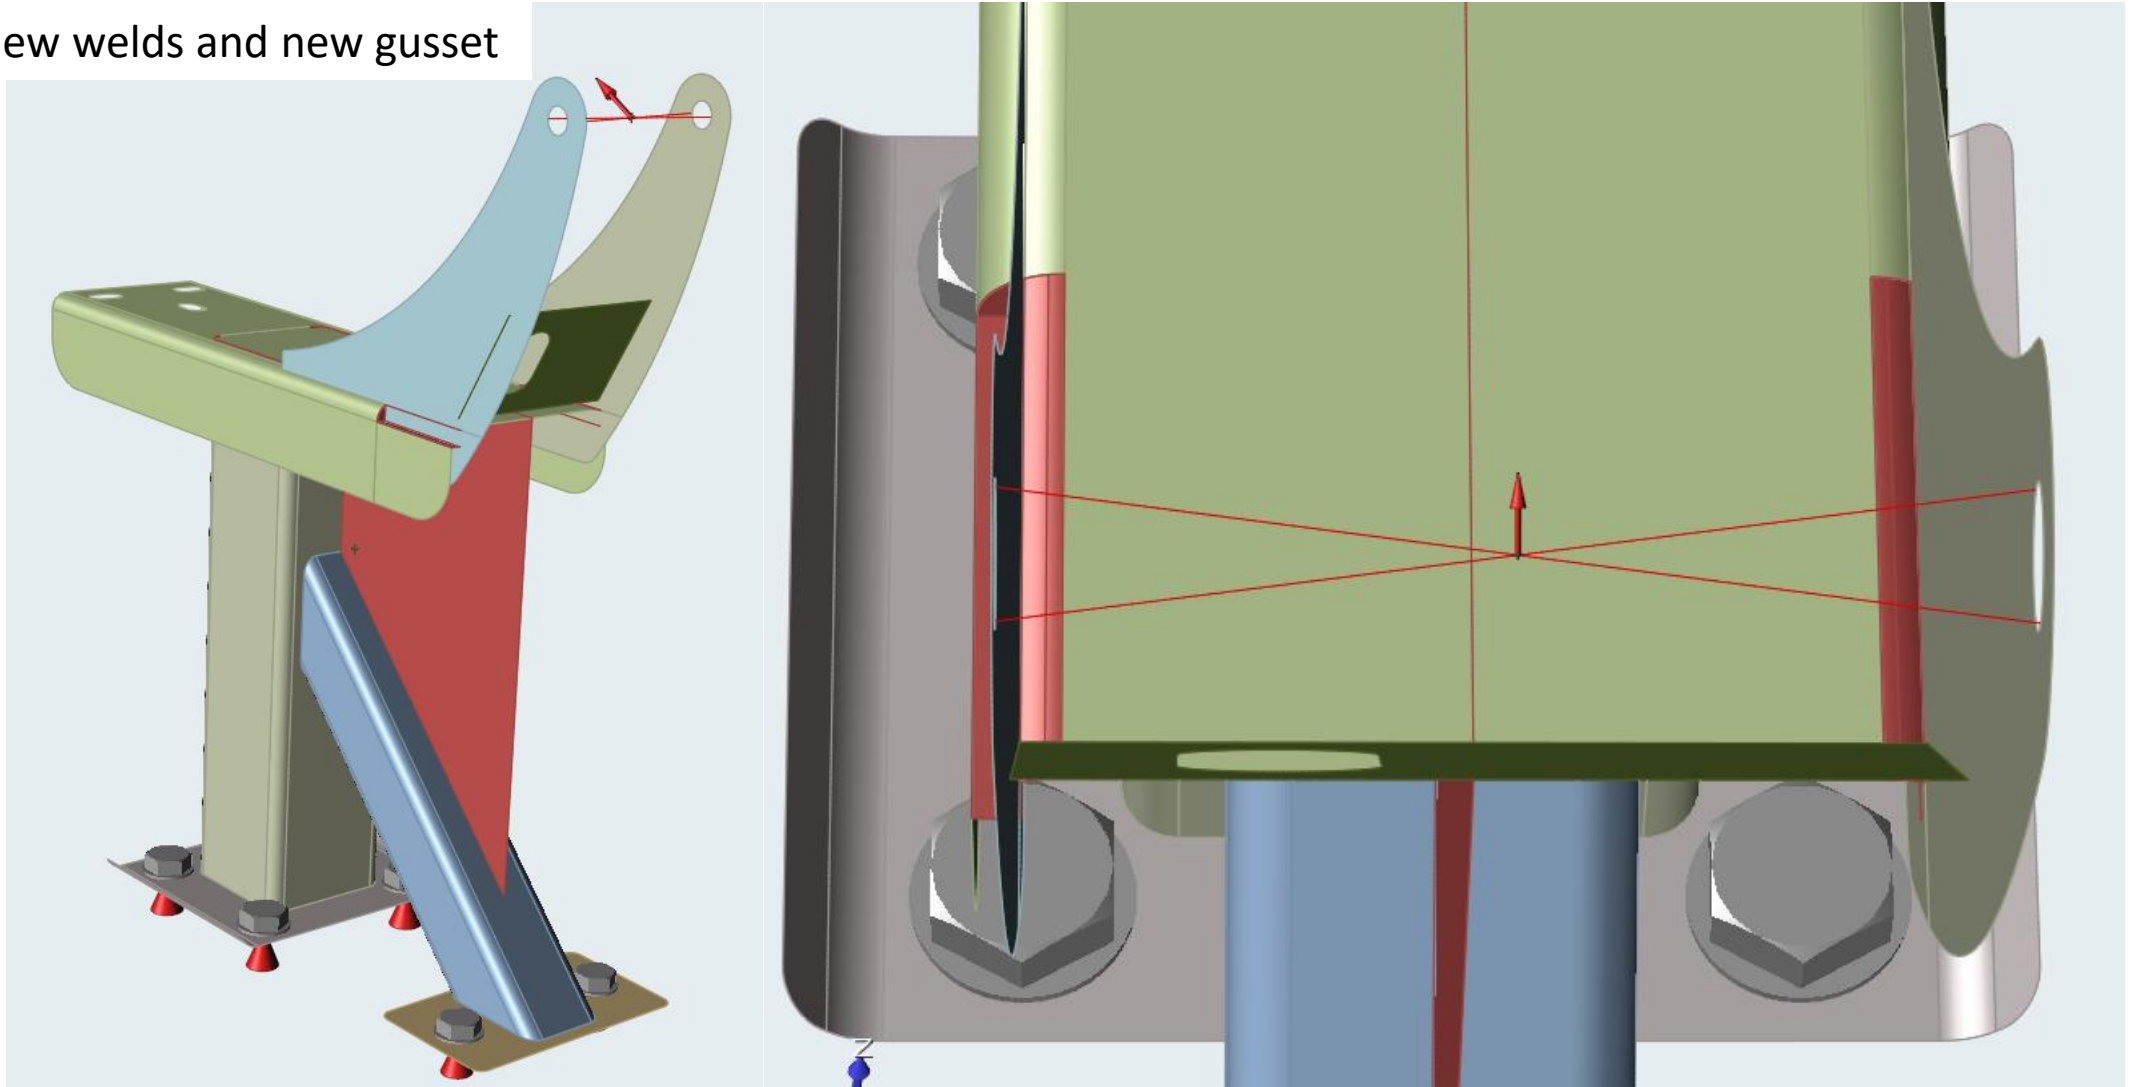
Oxide color are new welds and new gusset

Mod #5: Single $\frac{1}{4}$ " thick gusset, full 3x3 tube weld and filled in slots

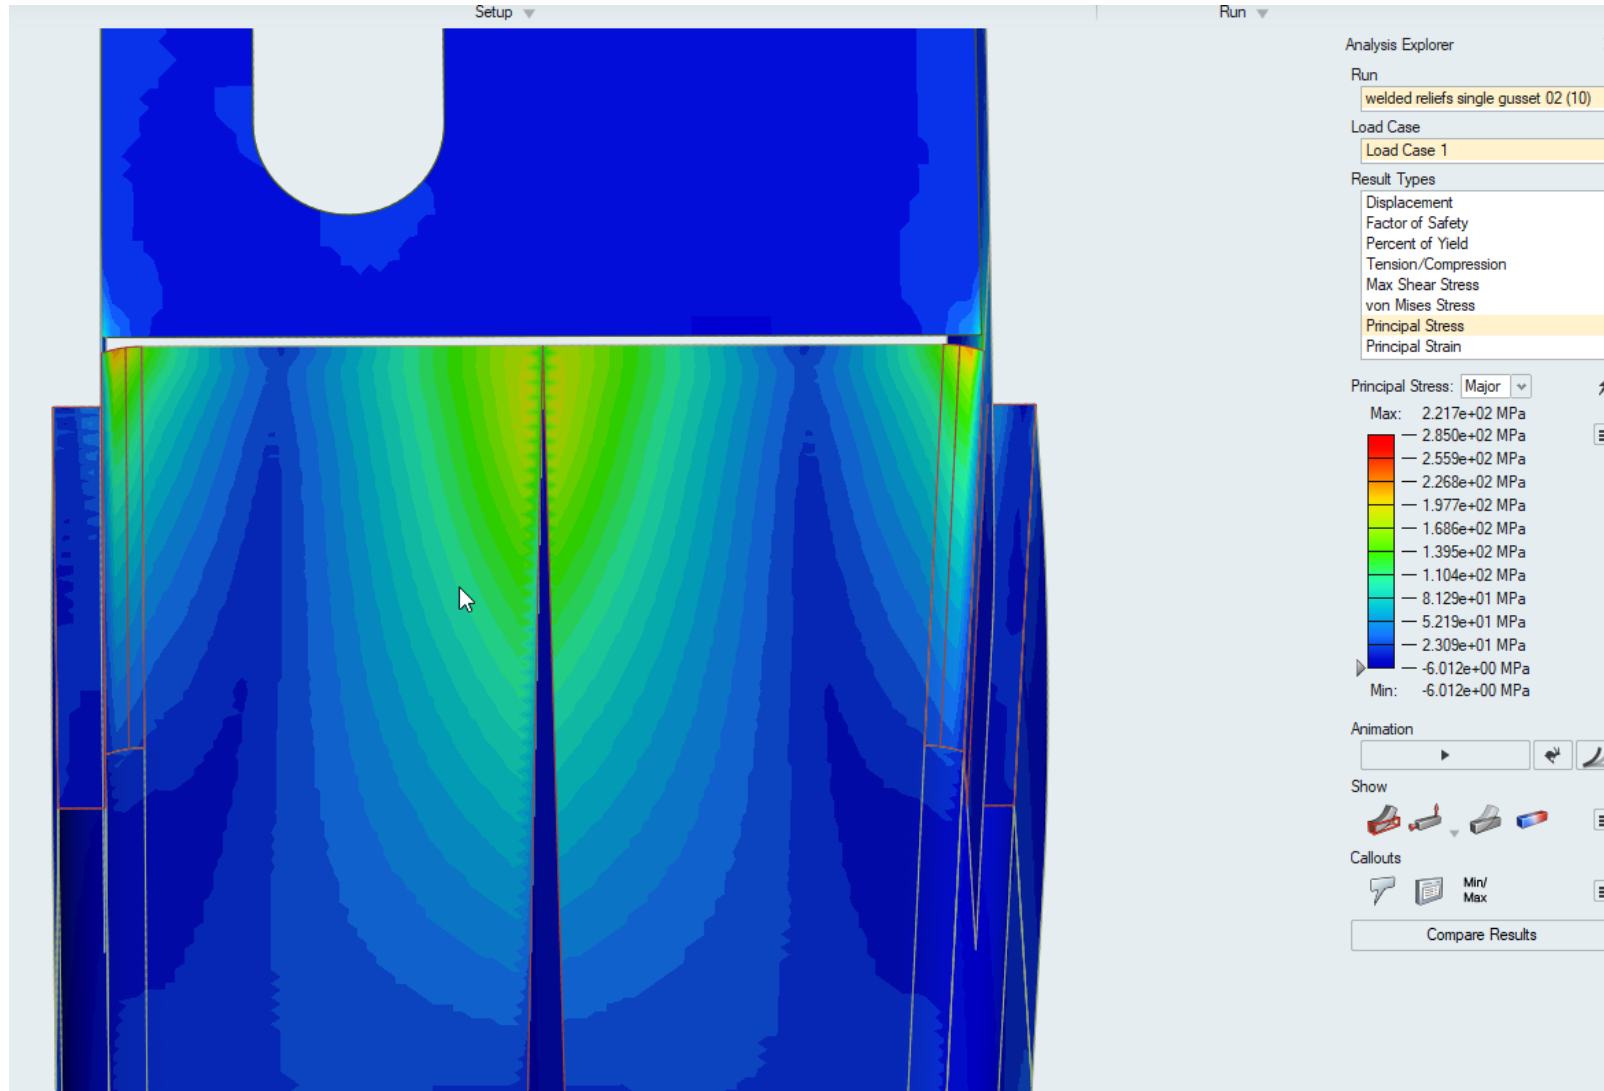
Mod #5 Results: Lowest stress and all areas are below yield stress

That little bit of orange in the slot welds can be eliminated by tailing off the weld upwards or downwards into the uprights. I don't believe this material is AISI 1015, my sense tells me it is closer to A36 since it is cheaper.

We started at 358MPa on the OEM winch stand and ended up at 222MPa which is a significant reduction in stress. Afterwards, I had to retighten the u-bolts as the winch stand would move forward when latching the Drotto. I put my Drotto in the lower hole and now I back in and fully submerge the bunks and I just idle in and bump the throttle – no more drama, just click, and then wifey pulls me out of the water.
